**20-0012-UT WTP3 - EAST DOME AND AERATOR AND MISC. IMPROVEMENTS  
Clearwater, Florida**

## **Condition Survey Report**

### **Water Treatment Plant 3 (WTP3) East Dome and Aerator and Miscellaneous Improvements**

**City Project No. 20-0012-UT**

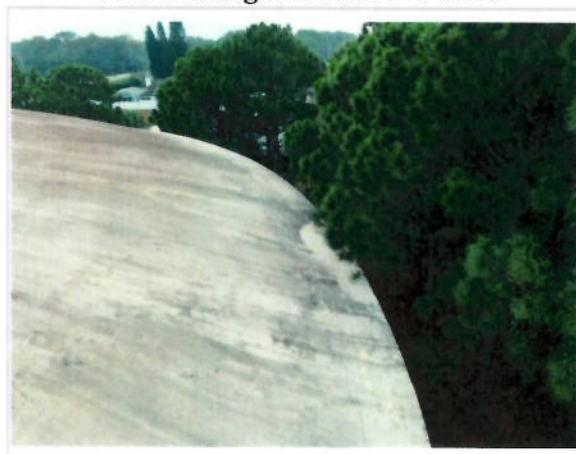
Tree coming in contact w/ tank

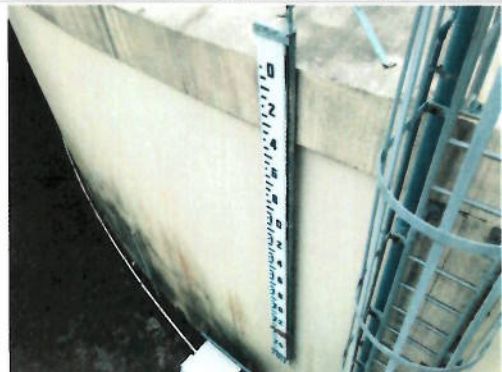
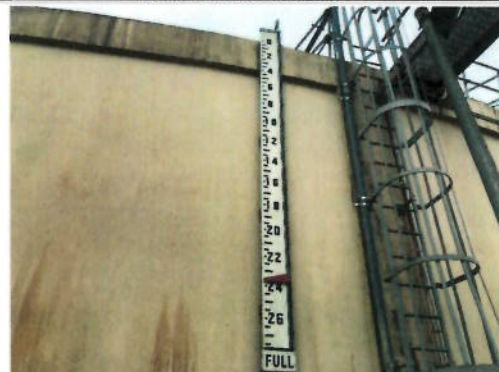
Overall Condition: Excellent to Good

Additional Notes: - Attached & accurate reading  
- Minor mildew staining present throughout  
- Minor organic growth noted  
- Constructed of fiberglass

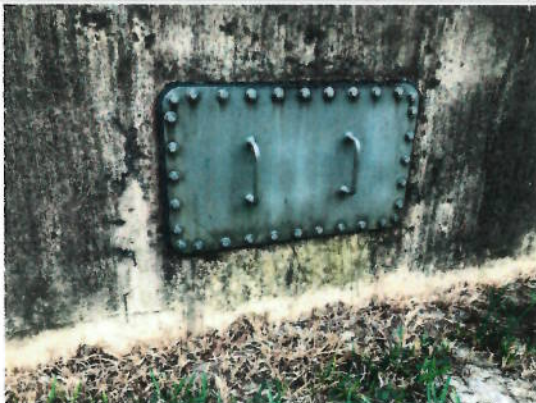
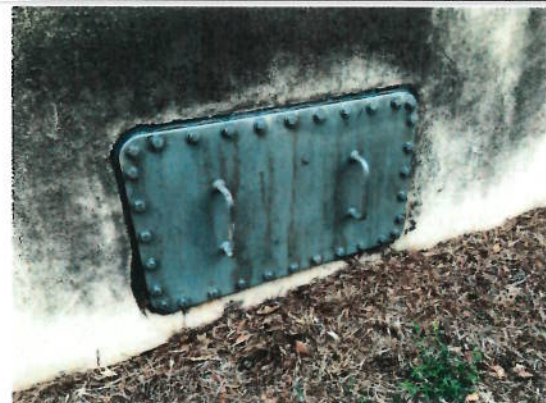
### Overall Condition: Excellent

- Additional Notes:**
- Tank equipped w/ two(2) manways
  - Both manways share equivalent ratings
  - Minimal discrepancies to be noted
  - Minor to moderate mildew staining throughout

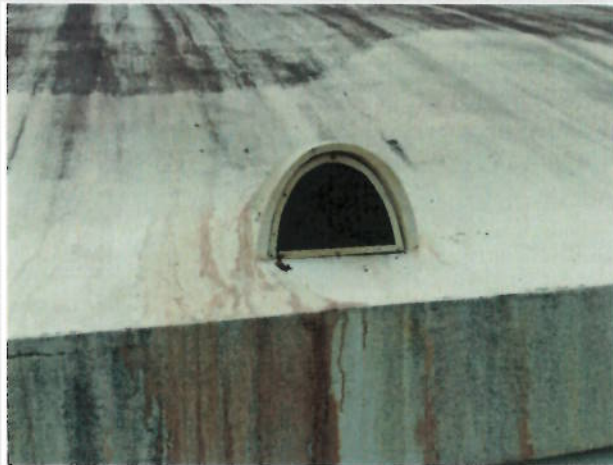
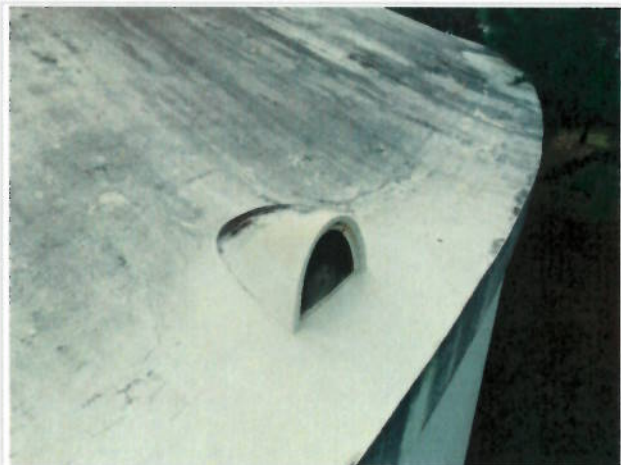
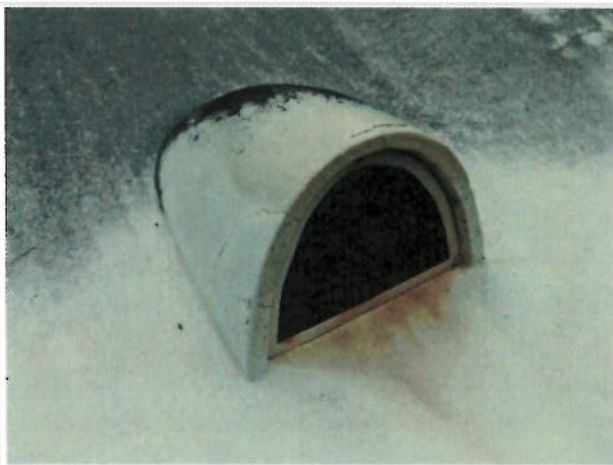
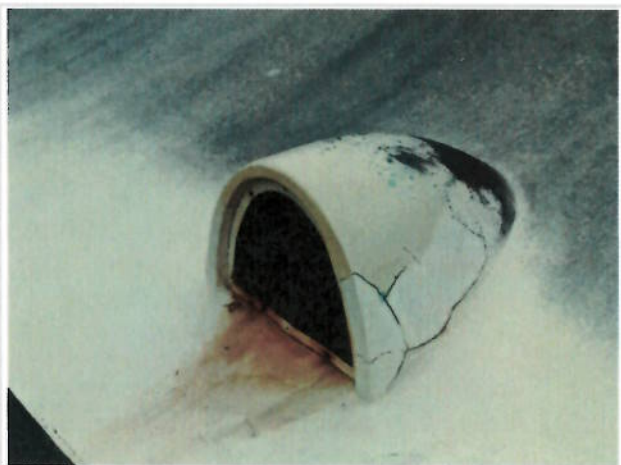
**Overall Condition:** Good to Fair

- Additional Notes:**
- Tank equipped w/ six(6) "frog-eye" style overflows
  - All overflows share consistent ratings
  - Minor sags & runs present throughout
  - Minor to moderate mildew staining noted
  - Minor to moderate hairline cracking present
  - Corrosion isolated on hardware

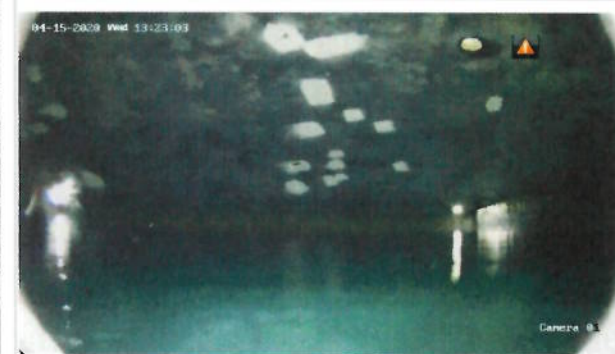
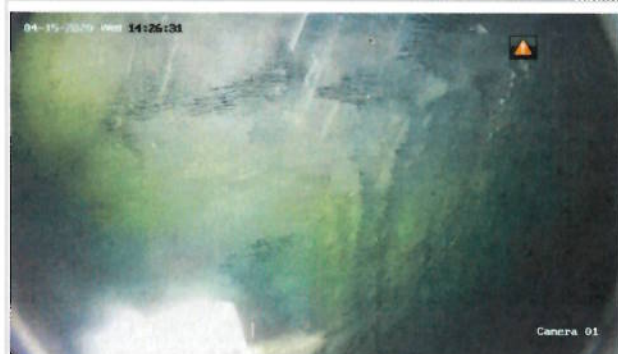
**Overall Condition:** Good to Fair

- Additional Notes:**
- Repairs noted throughout roof (some failed)
  - Moderate to heavy concrete spalling present
  - Moderate exposed reinforcements noted
  - Heavy bug-holing present throughout
  - Corrosion isolated on exposed reinforcements

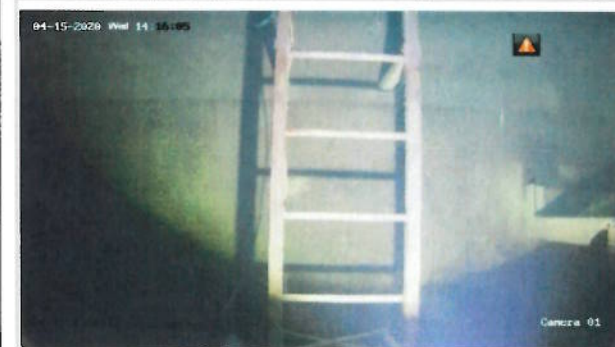
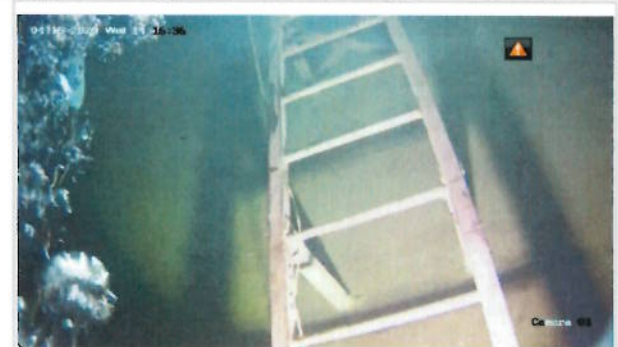
**Overall Condition:** Excellent to Good

- Additional Notes:**
- Fiberglass ladder w/ gel coating
  - No safety climb present
  - Minimal discrepancies to be noted
  - Moderate sediment staining present

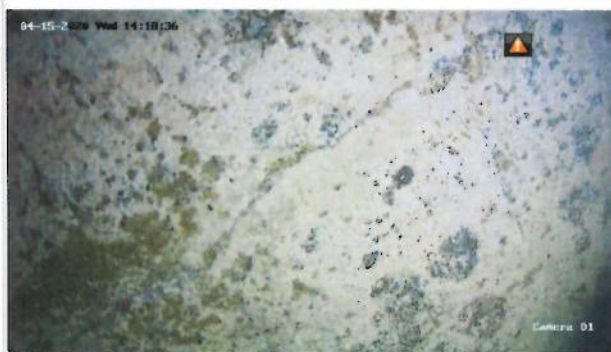
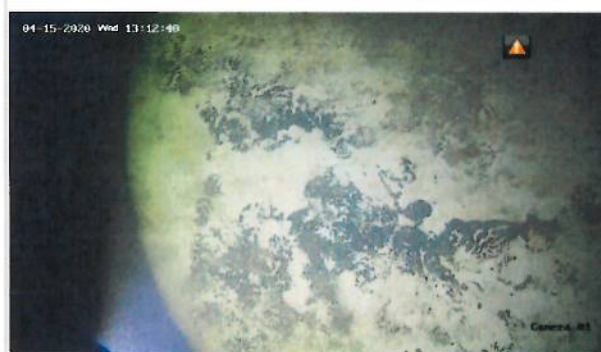
Overall Condition: Good

**Additional Notes:** - Consistent ratings throughout  
 - Unlocalized unevenness & concrete over-pour noted  
 - Sloped perimeter / floor to wall seams  
 - Coating present in unlocalized areas throughout  
 - Moderate sediment staining present  
 - Minor exposed aggregate & hairline cracking  
 - Minor scaling / small pop-outs noted

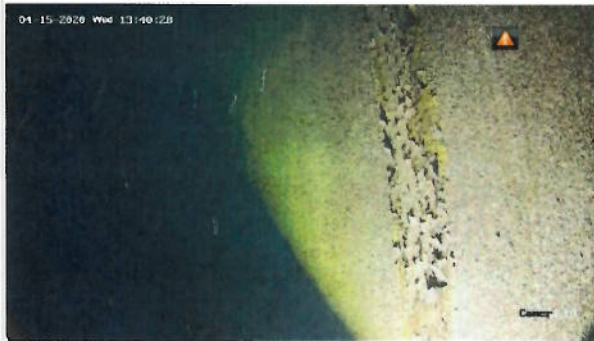
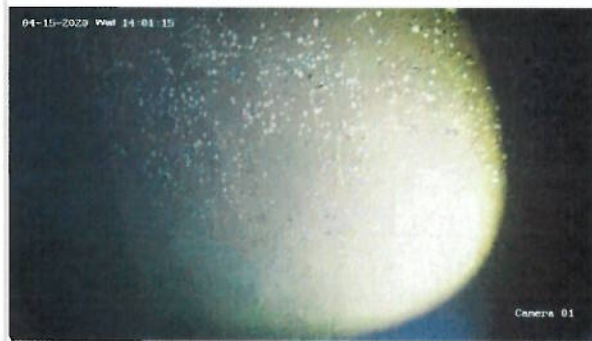
Overall Condition: Good

**Additional Notes:** - Concrete block baffle wall (9:15 closed - 3:15 open)  
- Heavy blistering noted on baffle wall (micro-large)  
- Coating failure present on exterior walls  
- Minor to moderate small pop-outs noted  
- Checking & cracking noted throughout coating  
- Moderate sediment staining present  
- Moderate exposed aggregate noted

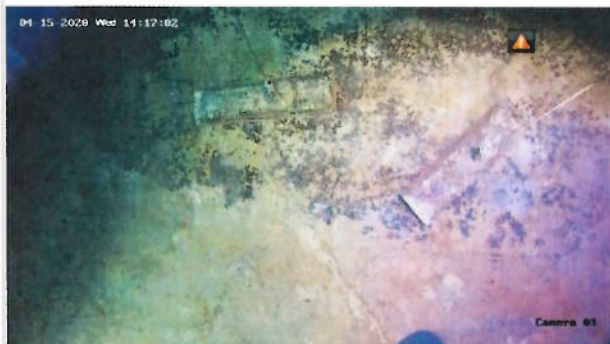
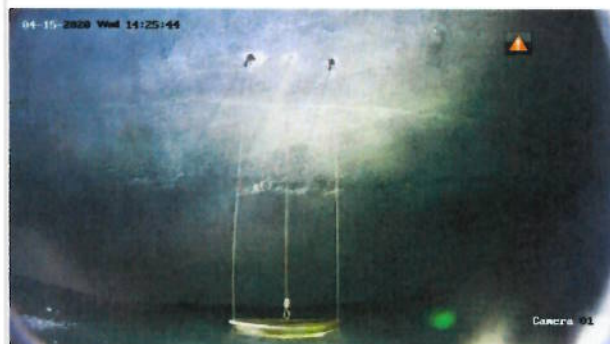
Overall Condition: Good

**Additional Notes:** - Constructed of fiberglass w/ gel coating  
- Attached & accurate  
- Guide wires properly anchored to dead-weights  
- Corrosion localized on hardware  
- Minor sediment / corrosive staining

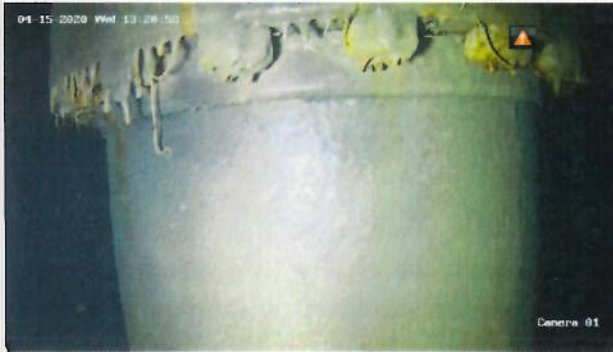
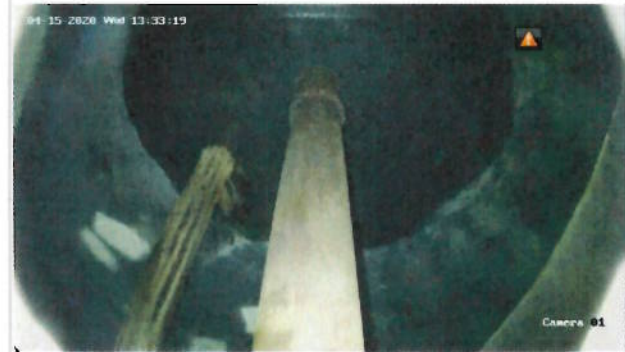
- Primary inlet penetrates through floor & roof
- Secondary inlet penetrates through floor (12:05)
- Primary inlet equipped w/ two(2) down-comer pipes
- Minor to moderate saggs & runs (heavier on flanges)
- Minor corrosion (< 1%) / staining on secondary inlet

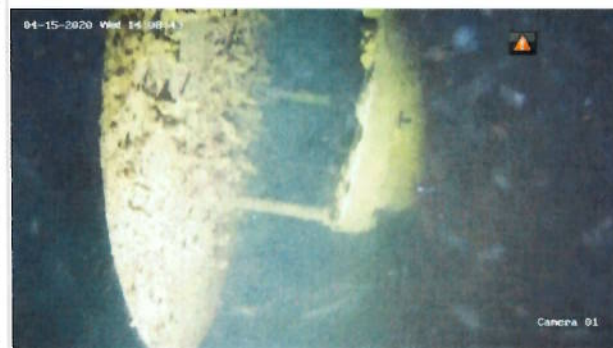
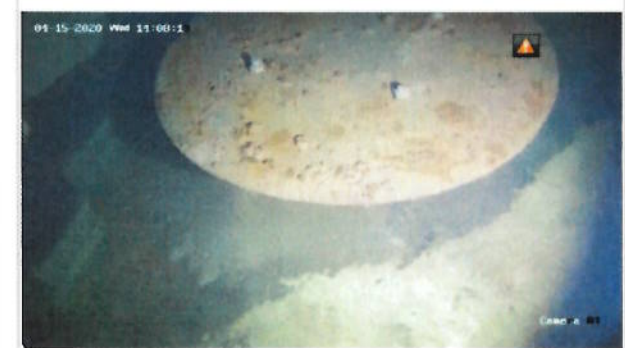
- Outlet penetrates into floor (ratings above)
- Heavy corrosion localized throughout component
- Equipped w/ vortex plate cover
- Tank equipped w/ secondary crossover outlet
- Minor sediment staining & corrosion on crossover

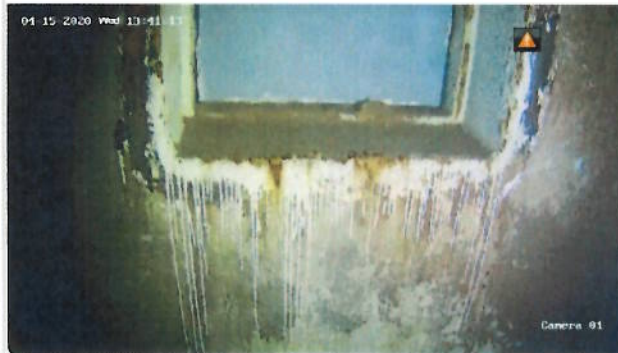
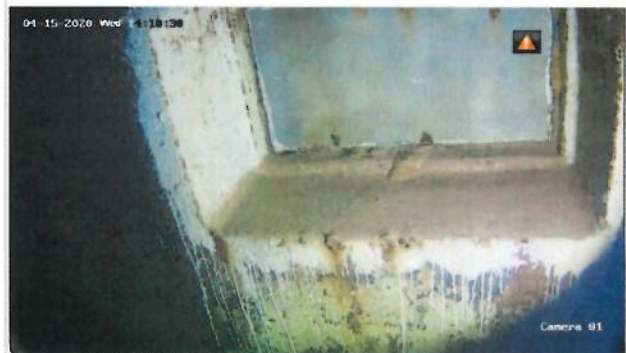
Overall Condition: Good

Additional Notes: - Both manways(2) share equivalent ratings  
- Coating present only on manway insert  
- Rust noduling isolated on seams  
- Heavy saggs & runs / blistering present throughout

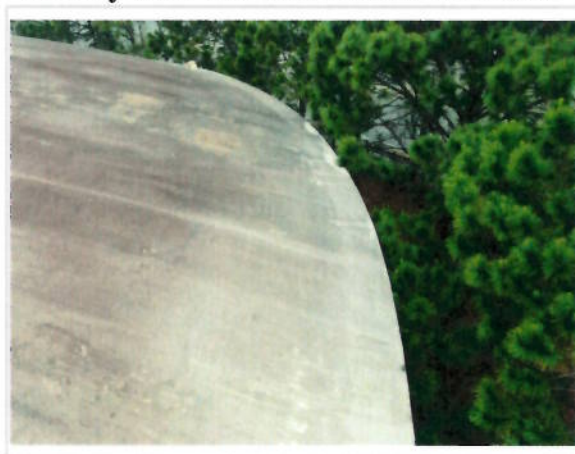
Nearby trees within close contact of tank

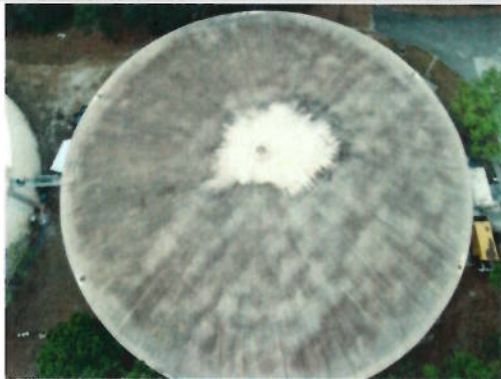
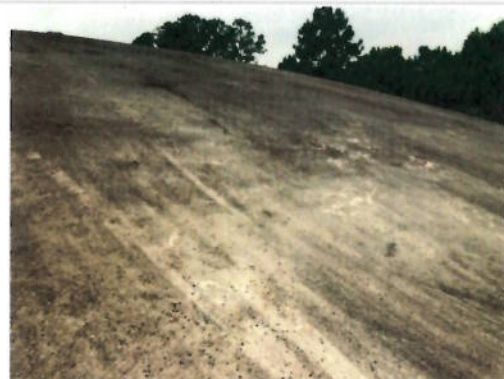
**Overall Condition:** Excellent to Good

**Additional Notes:** - Equipped w/ safety rail around access hatch  
- Equipped w/ six (6) "frog-eye" style overflows  
- Rating consistent throughout  
- Heavy mildew staining present throughout  
- Minor to moderate chalking noted

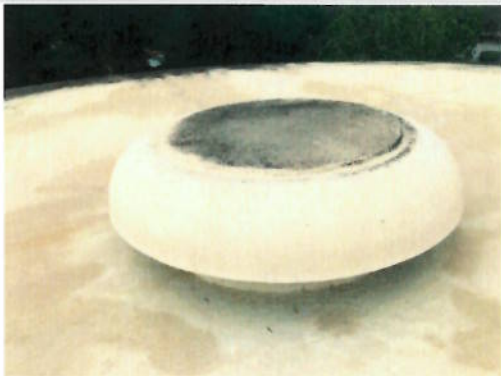
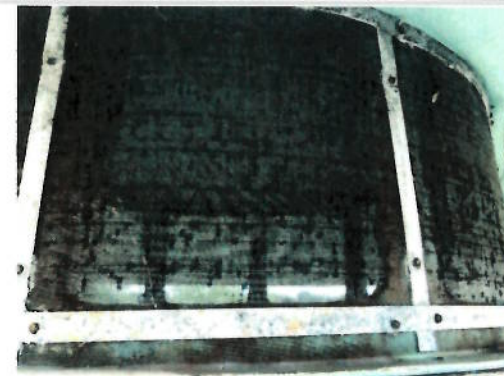
**Overall Condition:** Good

**Additional Notes:** - Minor deterioration noted present on screen  
- Corrosion isolated on hardware / screen  
- Vent cap constructed of fiberglass w/ coating  
- Minor hairline cracking noted on riser  
- Heavy chalking present on vent cap

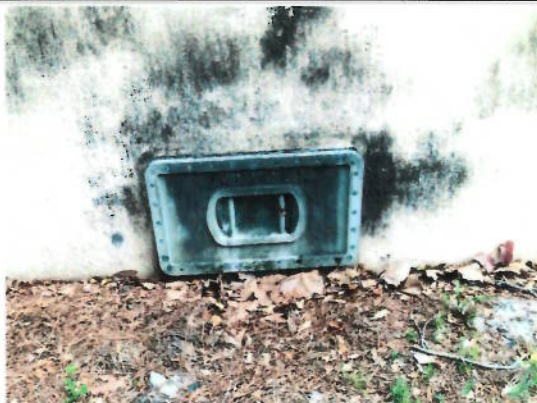
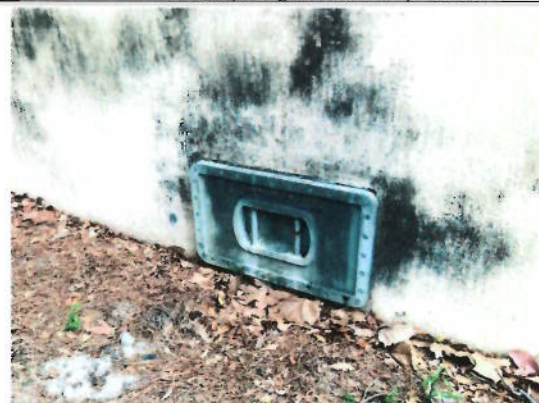
### Overall Condition: Good

**Additional Notes:**  
- Missing some hardware  
- Second manway buried below ground  
- Heavy mildew staining present  
- Minor spalling noted around penetration

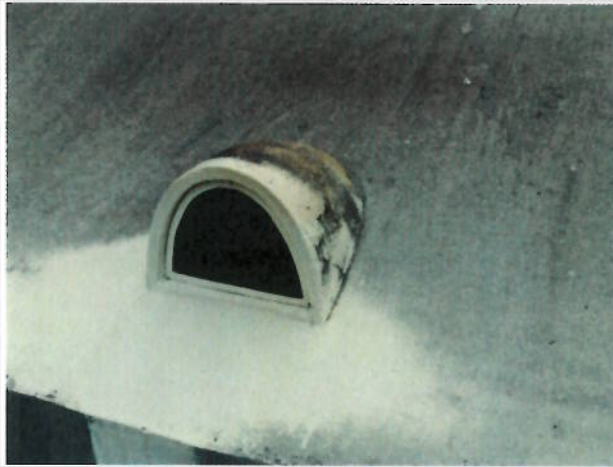
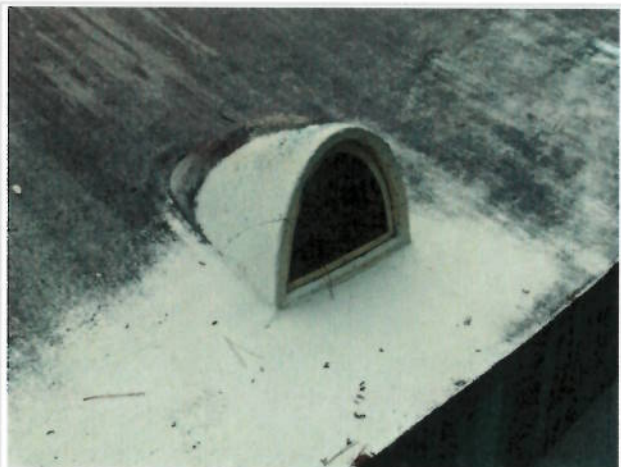
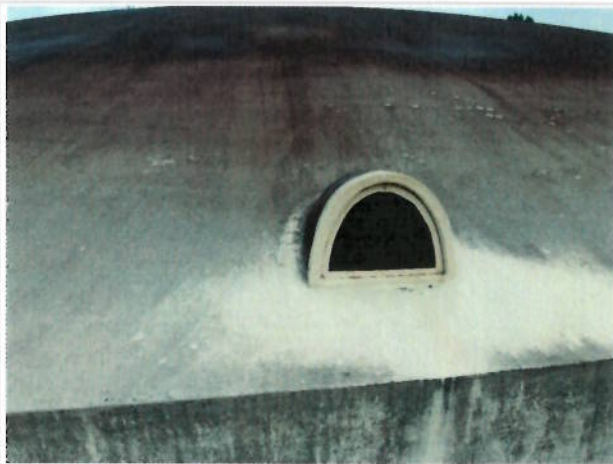
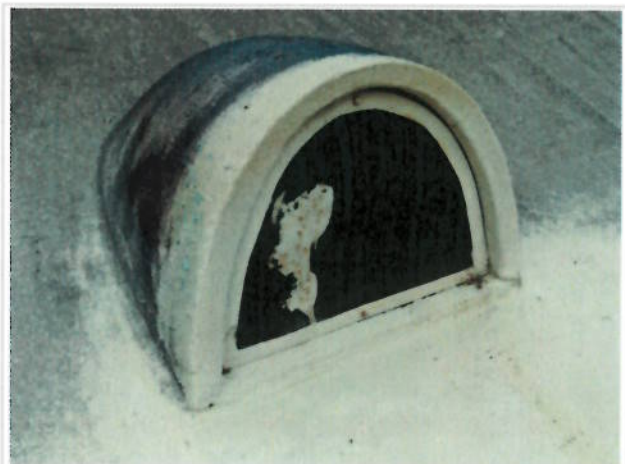
**Overall Condition:** Good to Fair

- Additional Notes:**
- Tank equipped w/ six(6) "frog-eye" style overflows
  - All overflows(6) share equivalent ratings
  - All screens present & intact
  - Minor to moderate sags & runs present
  - Minor corrosive staining noted
  - Minute corrosion isolated on hardware
  - Heavy mildew staining present throughout

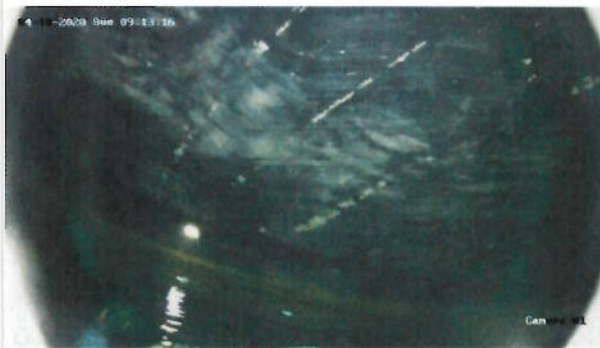
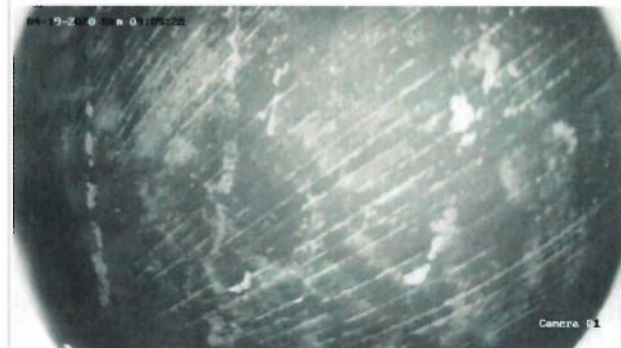
- Corrosion isolated on exposed reinforcements
- Heavy small - large pop-outs & spalling present
- Coating failure noted throughout
- Heavy exposed reinforcements present
- Minor hairline cracking / corrosive staining

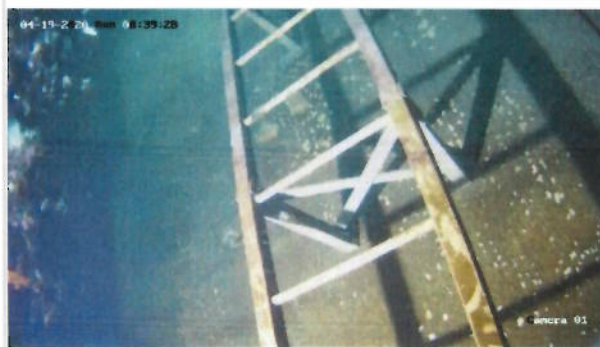
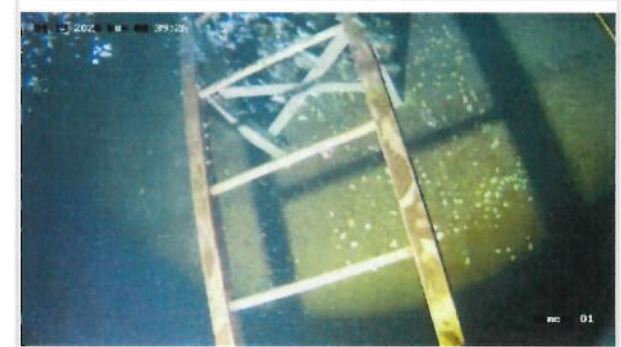
- Constructed of fiberglass w/ gel coating
- No safety climb present
- Minimal discrepancies to be noted
- Heavy sediment staining present throughout

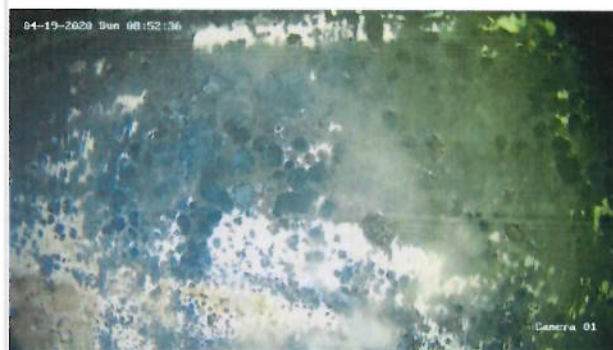
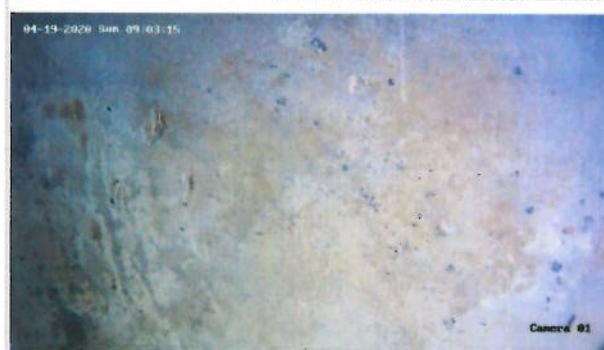
Overall Condition: Good

**Additional Notes:** - Sloped floor to wall seams  
 - Coating only present approx. 2' off of walls  
 - Moderate to heavy blistering noted in coating  
 - Minor concrete dusting present (no coating)  
 - Minor small pop-outs noted throughout  
 - Moderate sediment staining present  
 - Minor unevenness noted throughout

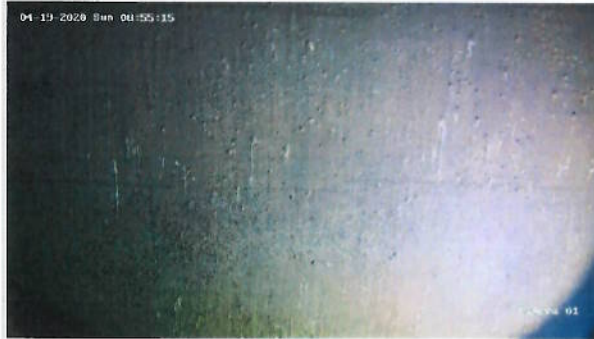
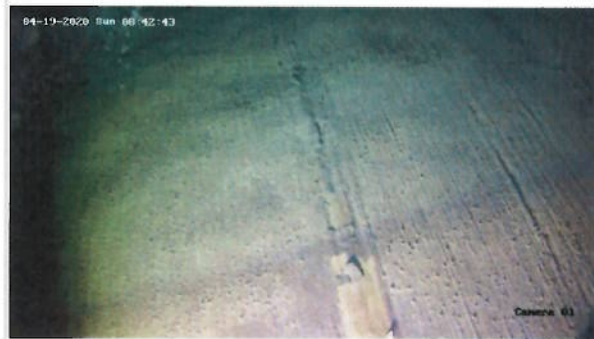
Overall Condition: Good

**Additional Notes:** - Consistent ratings throughout  
- Moderate signs of blistering noted in coating  
- D-lam & coating failure present throughout  
- Minor to moderate chalking present  
- Heavy sediment staining noted throughout  
- Minor hairline / shrinkage cracking noted  
- Minor to moderate saggs & runs present

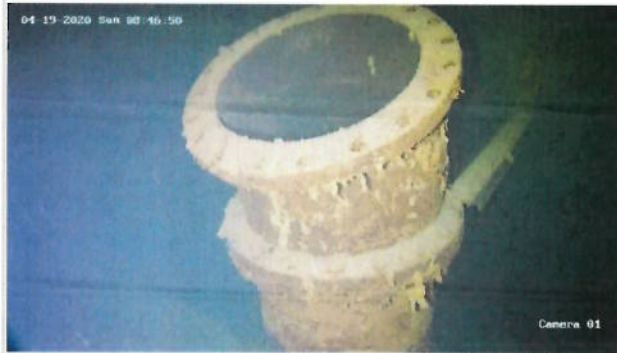
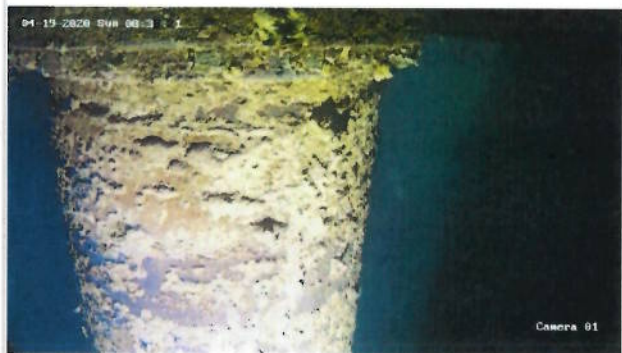
- Tank equipped w/ two(2) inlets
- Both inlets share equivalent ratings
- Constructed of iron (no coating present)
- Heavy corrosion noted throughout
- Heavy corrosive staining present

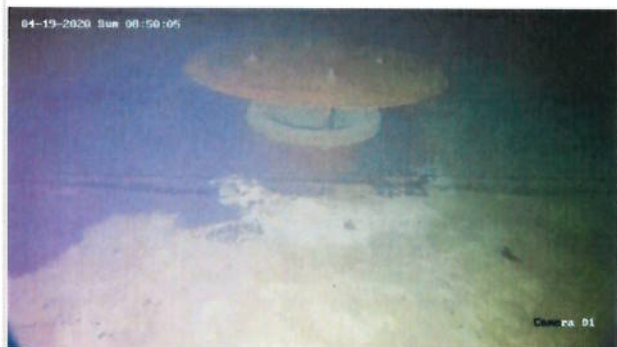
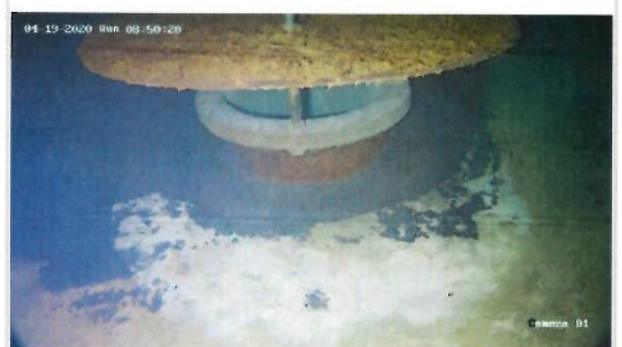
- Consistent ratings throughout
- Heavy corrosion noted throughout
- Heavy sediment & corrosive staining present
- Flange penetrates through tank floor
- No protective coating present

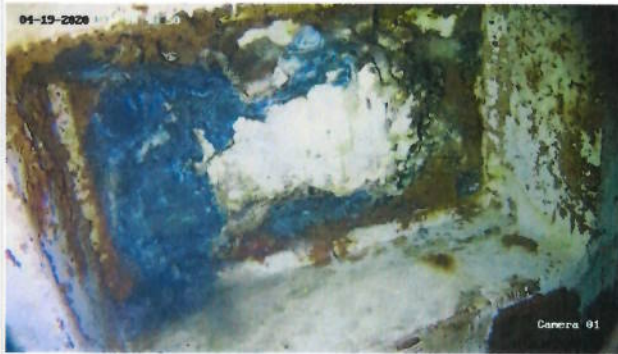
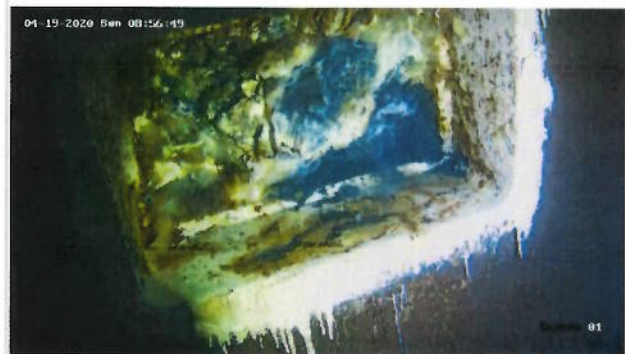
- Tank equipped w/ two(2) manways (one buried)
- Both manways share consistent ratings
- Heavy coating failure present
- Heavy corrosion and mineral growth noted

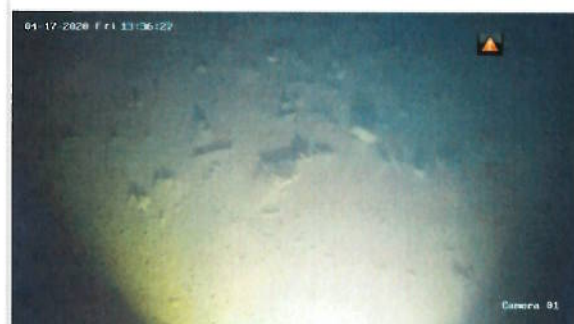
### Concrete spalling & sediment (before clean)
