September 10, 2020

**Re: Seawall Inspection Report for City of Clearwater Beach Marina
25 Causeway Blvd, Clearwater, FL 33767**

REUBEN CLARSON CONSULTING, INC.

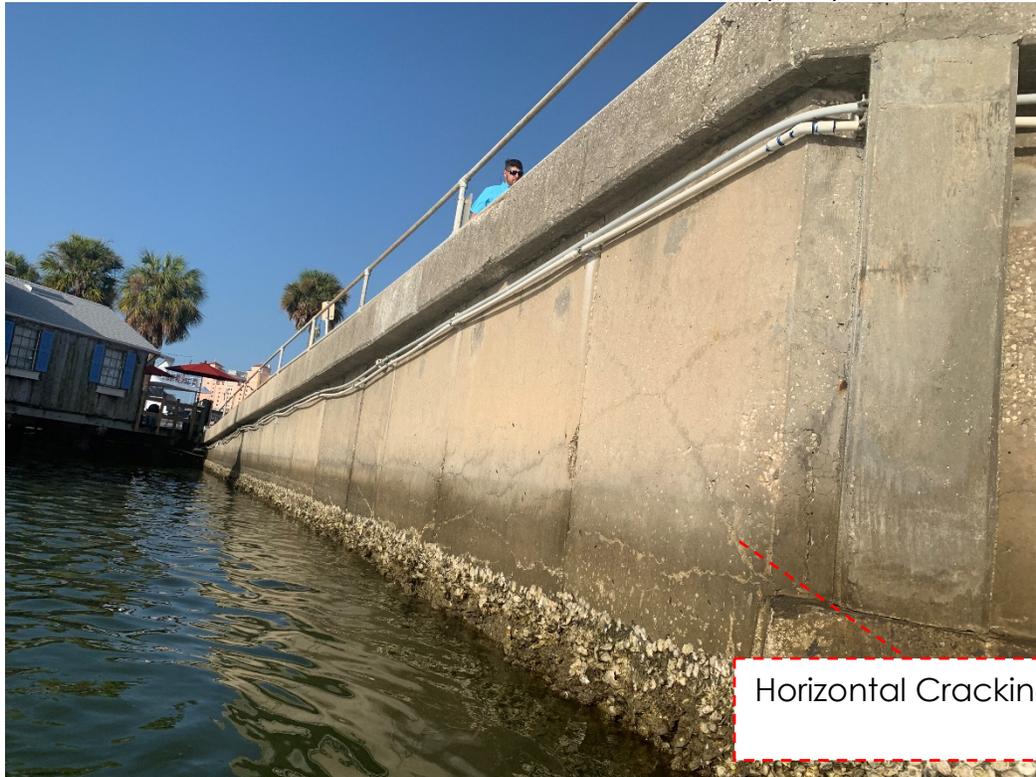
Photo #1- Start of Seawall at Northeast End of Property.

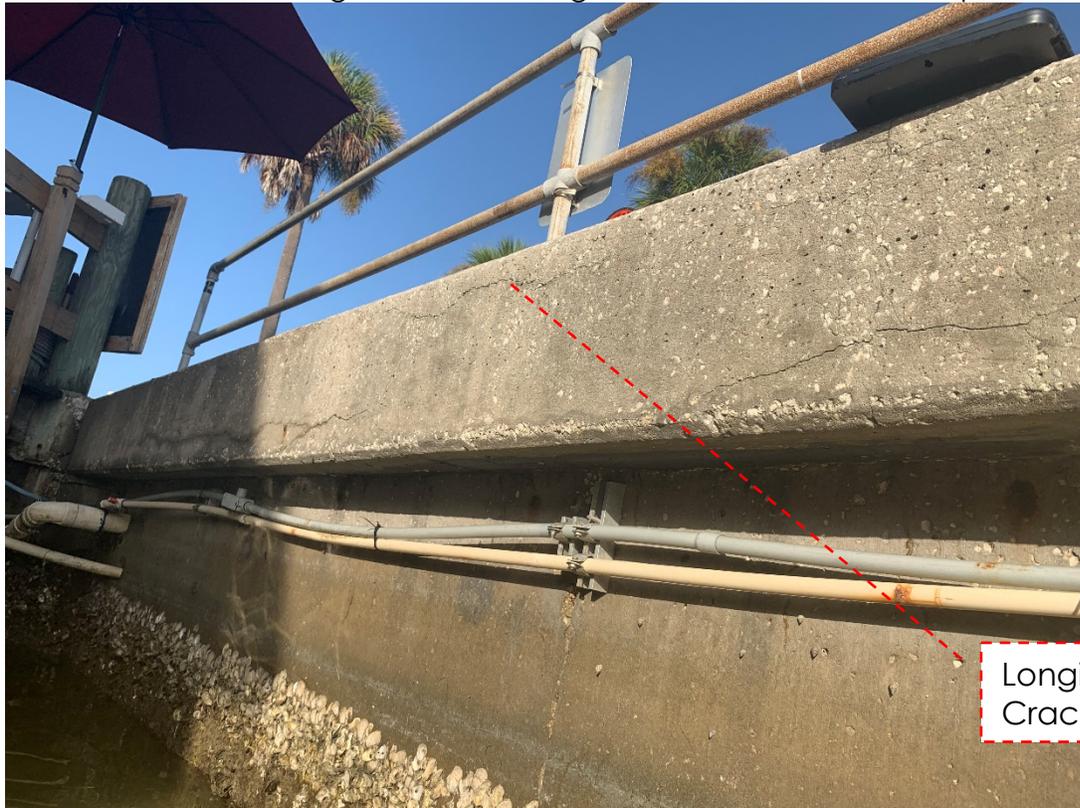
Photo #2 – View of Longitudinal Cracking in the Face of Seawall Cap at Northeast End.

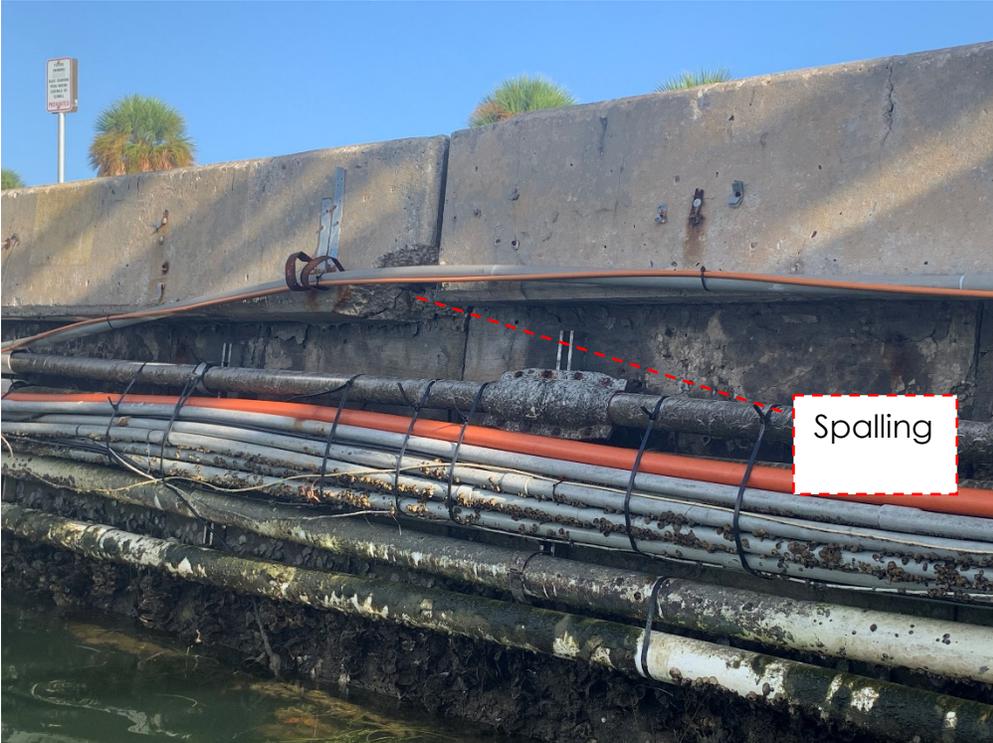
Photo #3- View of Spalling of the Seawall Cap.

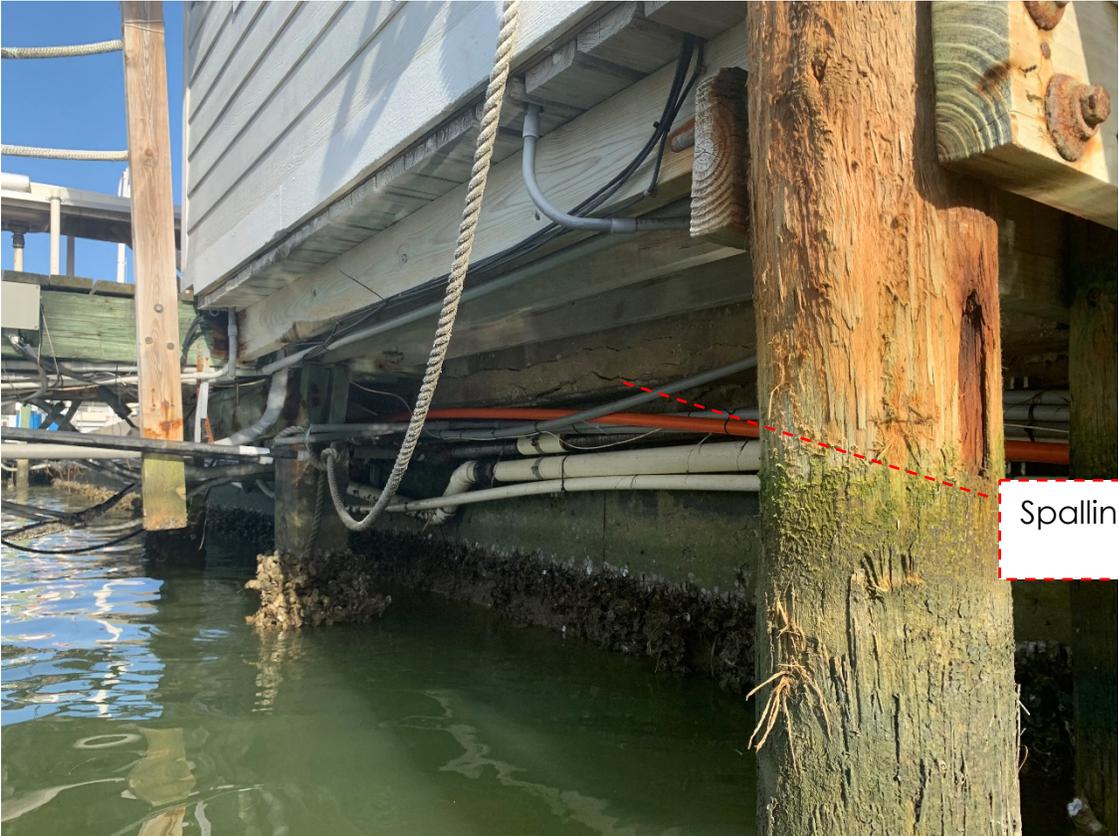
Photo #4- View of Spalling of Seawall Cap

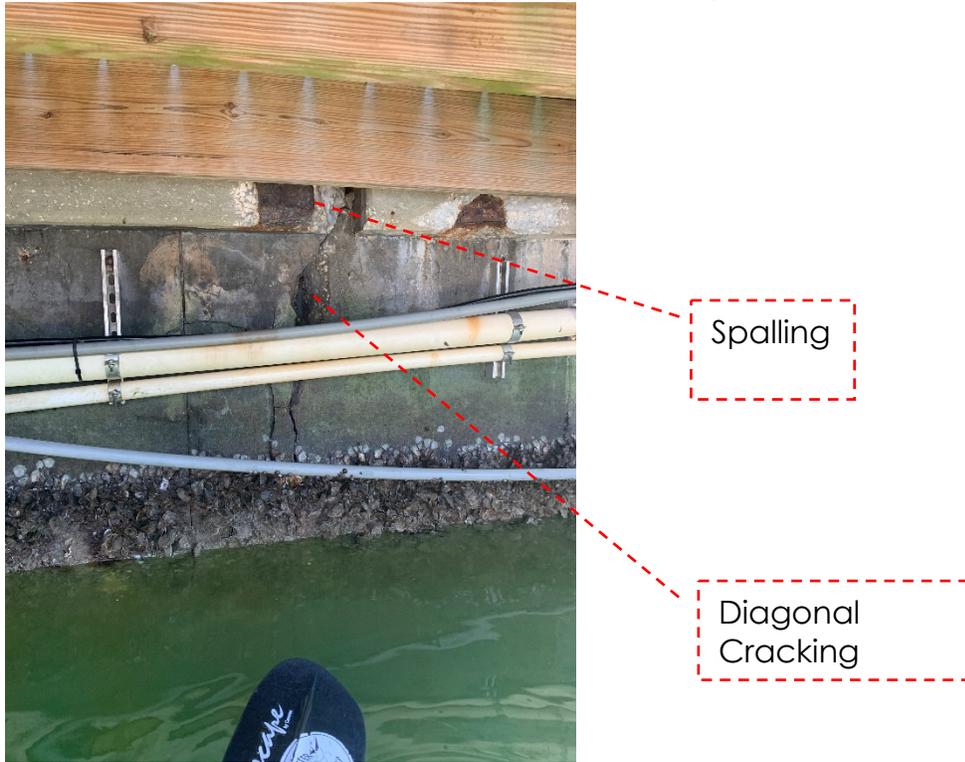
Photo #5 – View of Extensive Diagonal Cracking in Slab and Spalling of Cap

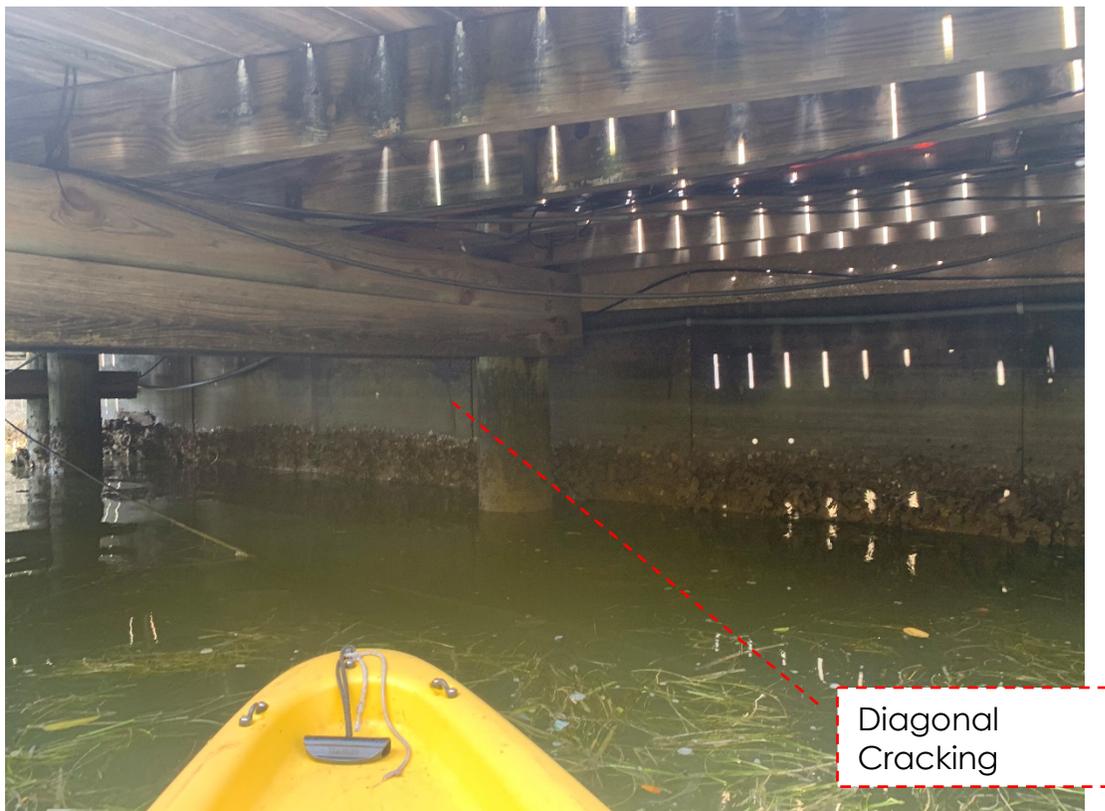
Photo #6 – View of Diagonal Cracking in Slab

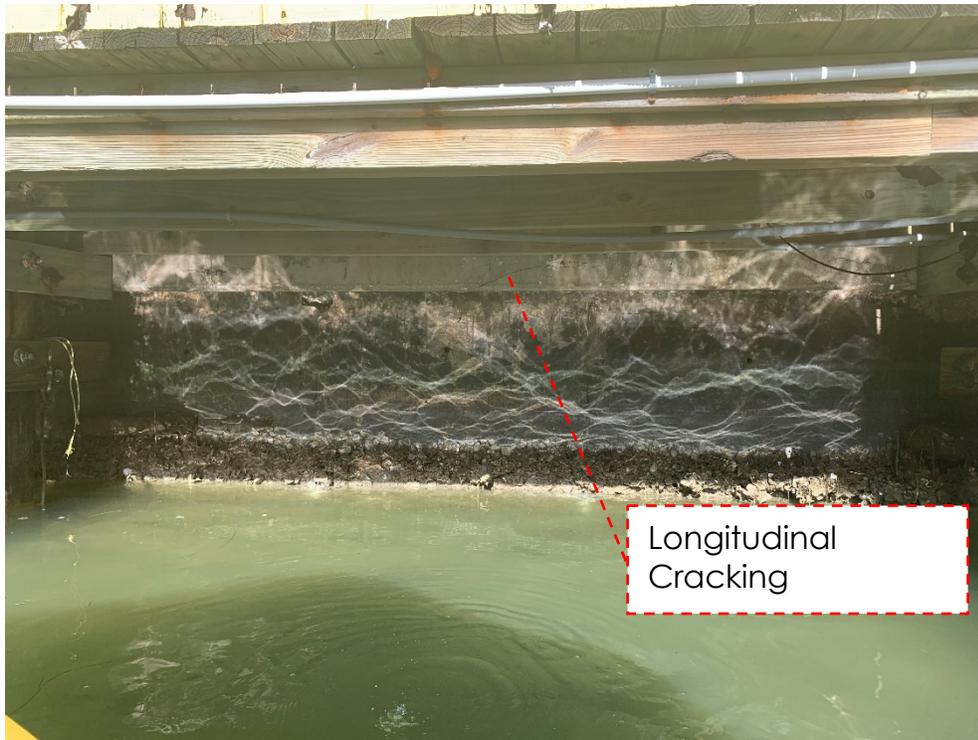
Photo #7 – View of Longitudinal Cracking in Face of Cap.
