**20-0012-UT WTP3 - EAST DOME AND AERATOR AND MISC. IMPROVEMENTS  
Clearwater, Florida**

## **Condition Survey Report**

### **Water Treatment Plant 3 (WTP3) East Dome and Aerator and Miscellaneous Improvements**

**City Project No. 20-0012-UT**

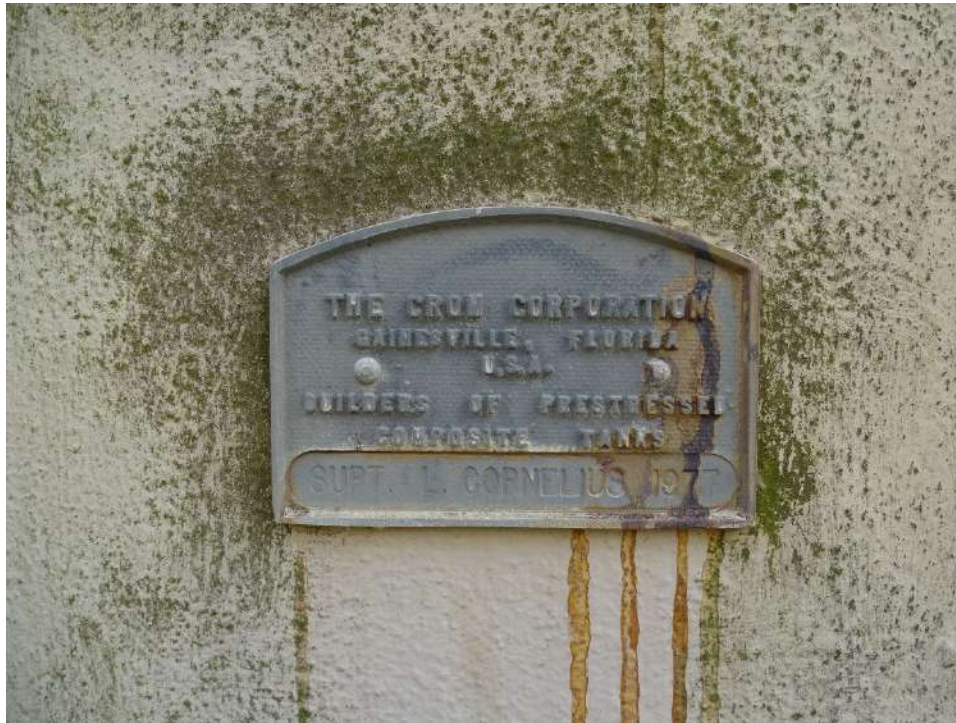
Figure A-1

<b>Table A – Structure Exterior Observations</b>	
<b>Conditions Observed</b>	<b>Reference Photos</b> (Figures in Appendix A and Appendix B)
<b>East Tank Walls</b>	
Typical conditions	
Tank plaque	A-1
Typical horizontal cracks within the middle third height of the tank walls; all crack widths are equal to or less than 1/64 inch	A-2 and A-3
Scattered locations of minor concrete pock marks and divots in the wall surface	A-4
Peeling wall coating at the interface with the ground/vegetation	A-5
Organic/water staining along the vertical surface of the dome ring; there is a typical color differential on the face of the dome ring adjacent to the overflows	A-6
Typical organic staining within the lower third height of the walls and around the dome ring	A-7
View of cementitious finish and paint coating applied to the wall surface	A-8
West sector overview	A-9 thru A-11
Section of concrete previously spalled off (painted over)	A-12

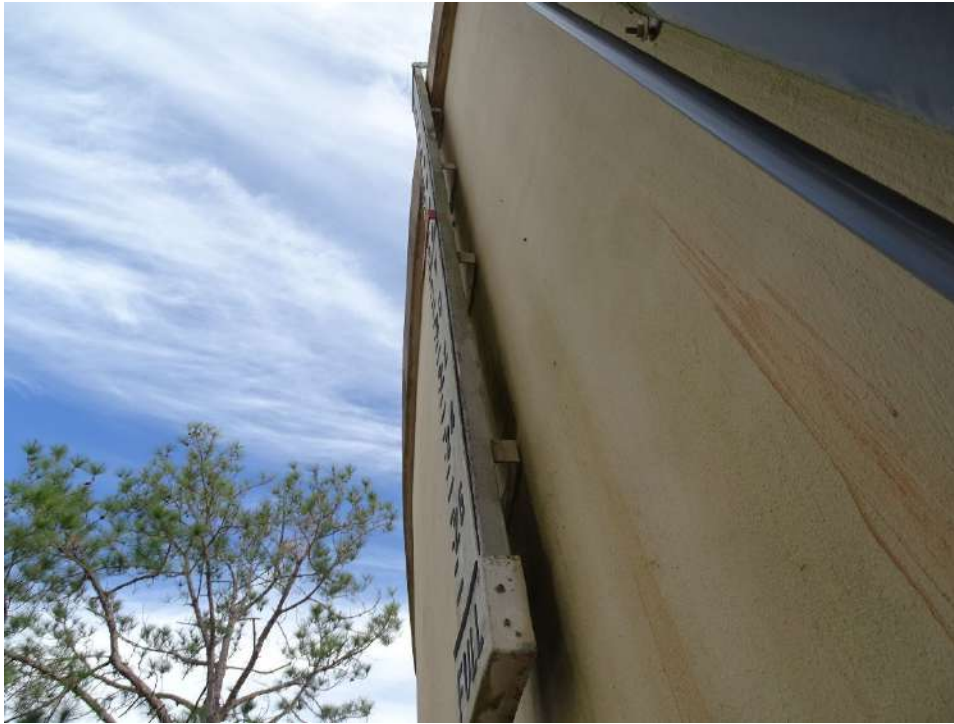
**Figure A-13**

Water level gauge fastened into wall at 4 locations	A-13
2-inch built out section of concrete wall facilitates the fastening of the access ladder and conduits	A-14
Area of delaminated concrete adjacent to the dome ring at the top of the wall (approximately 1'x2')	A-15
Northwest sector overview; heavy organic staining on walls in this sector	A-16 thru A-18
Worst case condition of horizontal crack on the wall surface, closer to the north; width appeared not to exceed 1/64"; water staining appears to be emanating from the cracking; organic growth was observed in the cracking	A-19
North sector overview; heavy organic staining on walls in this sector	A-20 thru A-22
Manway at lower wall level; peeling of coating and paint finish around the perimeter; the seal around the perimeter of the manway appeared weathered; no observed leaking	A-23 and A-24
Peeling paint at the dome ring directly above the manway	A-25

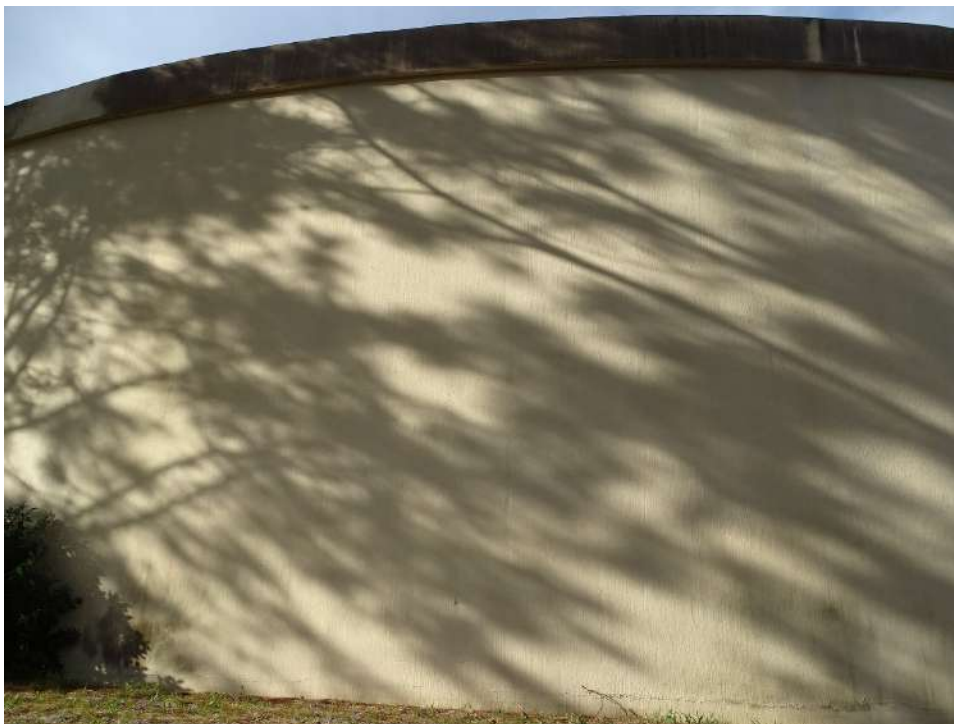
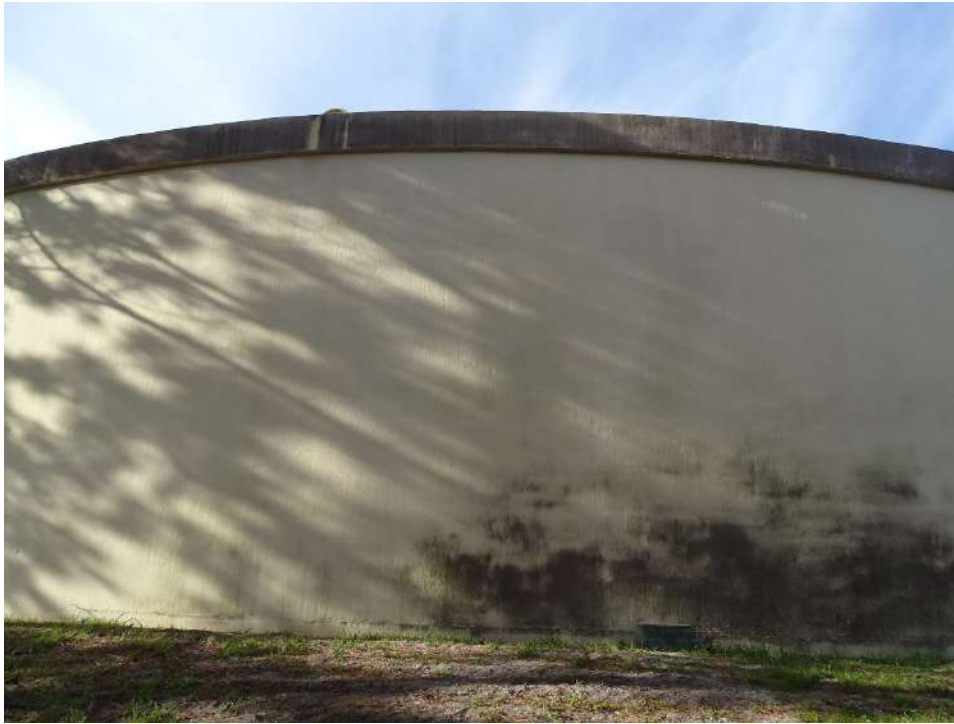
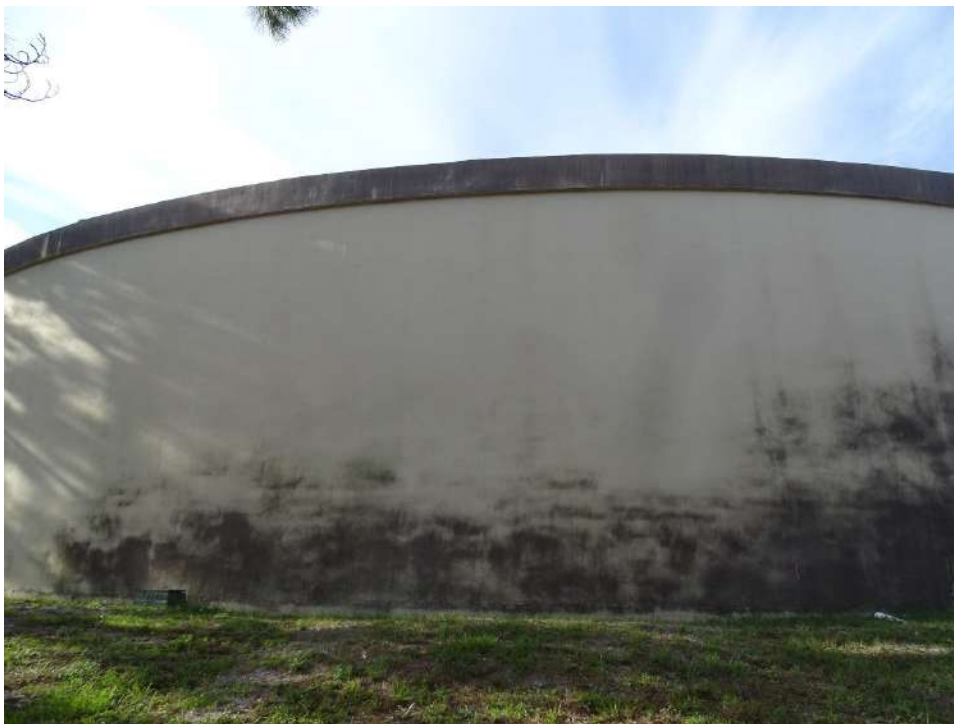
Northeast sector overview	A-26 thru A-28
Typical conditions observed	
East sector overview	A-29 thru A-31
Location of staining emanating from imperfection in the wall surface (closer to the northeast sector)	A-32
Southeast sector overview	A-33 thru A-35
Typical conditions observed	
South sector overview	A-36 thru A-38
Staining on the wall surface emanating from the roof	A-39
Abrasions in the wall surface; closer view of staining emanating from roof	A-40
Manway at lower level of the wall surface; the seal around the perimeter of the manway appeared weathered	A-41 and A-42
Delaminated area of concrete (approximately 5'x1') at the dome ring closer to the west quadrant	A-43
Apparent concrete repair at the wall surface adjacent to the delaminated concrete at A-43	A-44
Southwest sector overview	A-45 thru A-47
Abandoned fastening holes adjacent to the conduits and control valves	A-48 and A-49
Area of delaminated and spalled concrete at the upper section of the wall surface (approximately 0.5 sq.ft.)	A-50 and A-51

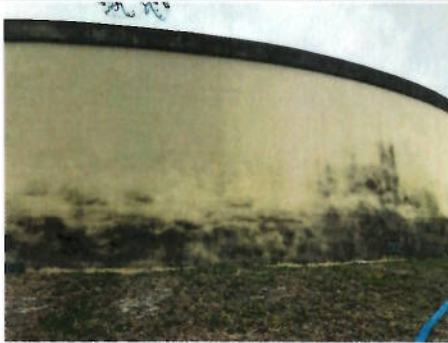
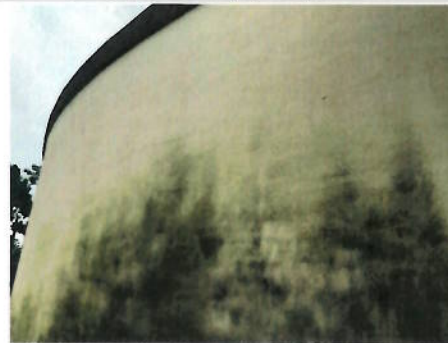
### Wall Panel Condition

- Bushes / trees coming in contact w/ walls
- Consistent ratings throughout
- Moderate mildew staining present
- Minor to moderate cracking noted throughout
- Minor small pop-outs present

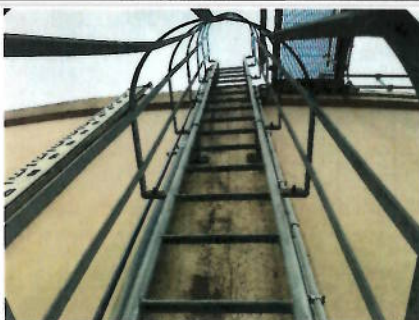
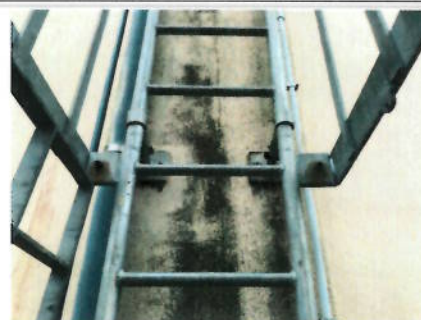
### Access Ladder Condition

- No protective coating present
- Minimal discrepancies to be noted
- Minor corrosion isolated on hardware
- Equipped w/ elevated walkway to adjacent tank
- Roof access equipped w/ safety handrail

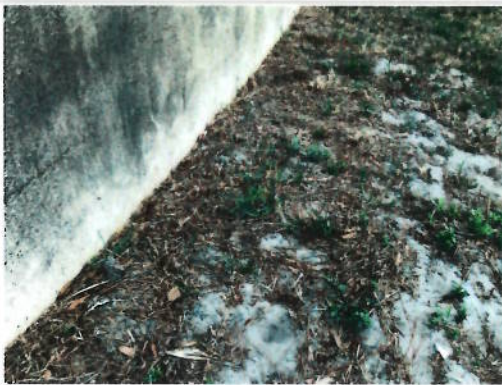
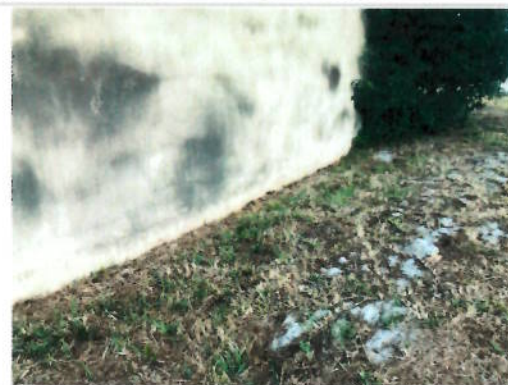
## Foundation Condition

Additional Notes: \* Buried foundation, unable to evaluate \*

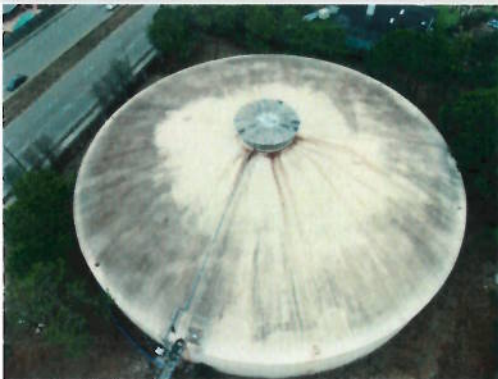
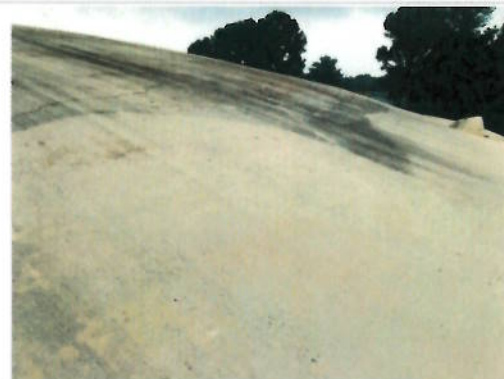
## Roof Condition

- Moderate to heavy mildew & sediment staining noted

- Moderate to heavy chalking present throughout

- Equipped w/ aeration system penetrating through roof

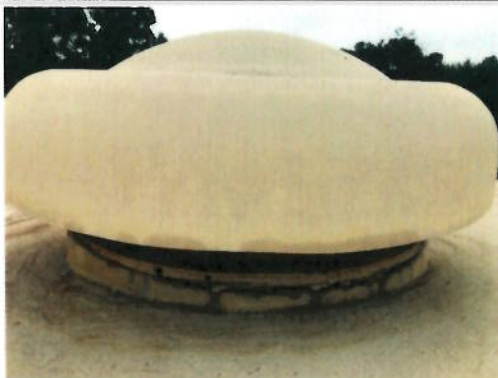
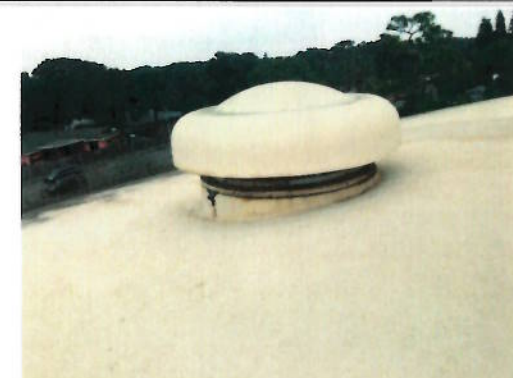
## Vent Condition

- Anchor bolts loose on north vent (loosely secured)

- Minor mildew & corrosive staining noted

- Corrosion isolated on hardware / screens

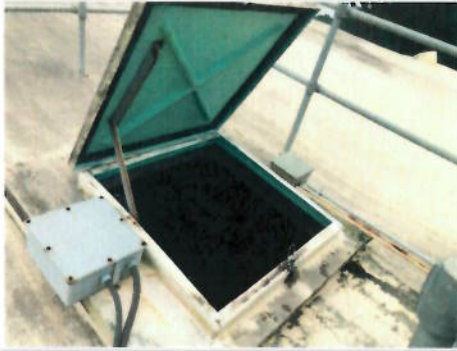
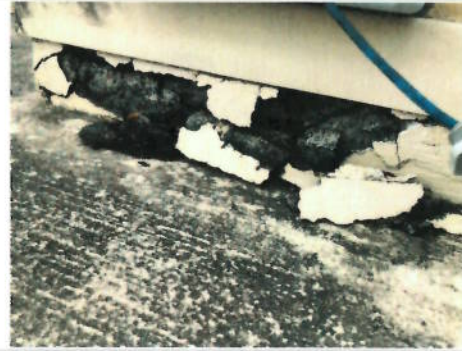
## Access Hatch Condition

### Overall Condition: Fair

- Additional Notes:**
- Access hatch constructed of fiberglass
  - Minor corrosion localized on hardware
  - Heavy mildew staining & chalking noted throughout
  - Equipped w/ safety handrail system
  - Heavy cracking on riser w/ severe concrete spalling

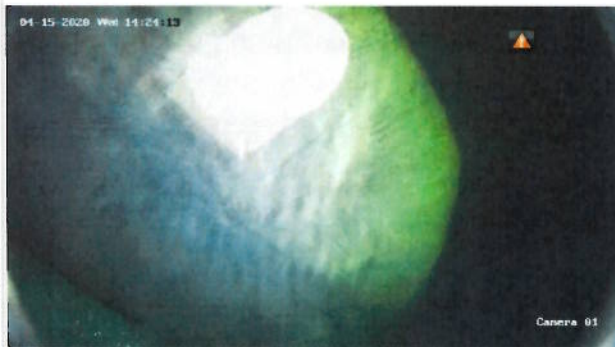
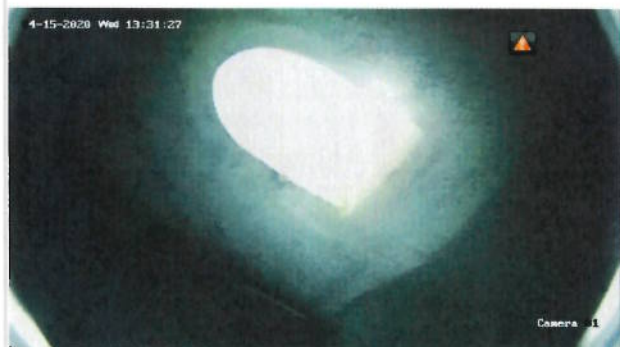
Additional Notes: - Tank equipped w/ six(6) "frog-eye" style overflows  
 - All overflows share equivalent ratings  
 - Minimal discrepancies to be noted  
 - Minor hairline cracking present throughout housing

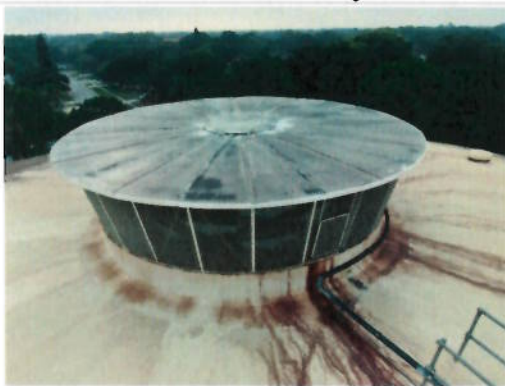
External aeration system

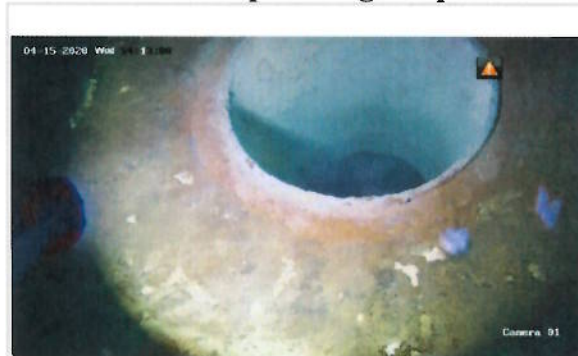
Cross-over plumbing component

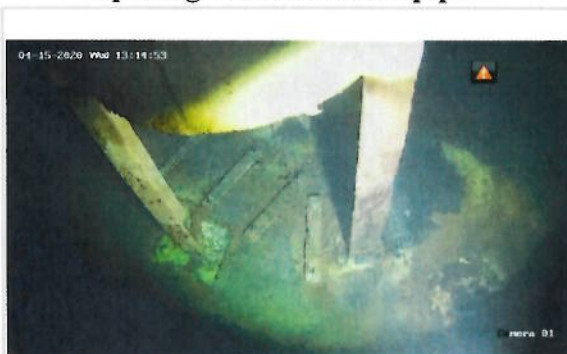
Opening of down-comer pipe

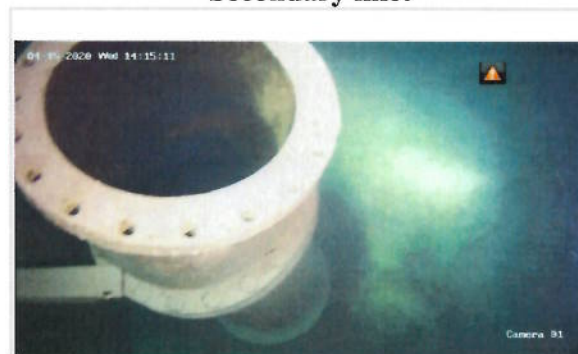
Secondary inlet

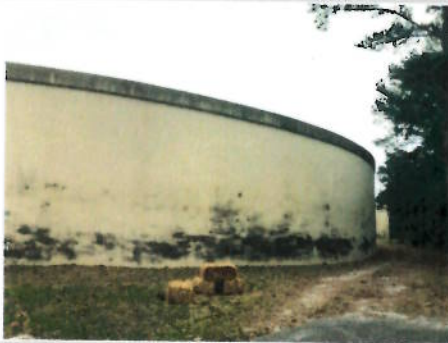
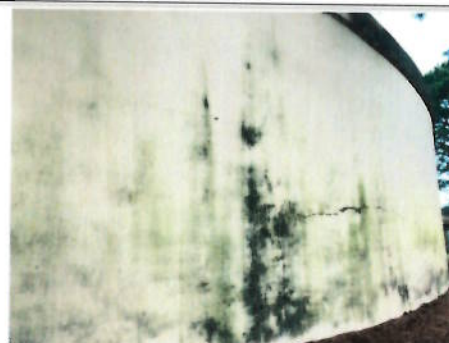
- Consistent ratings throughout
- Minimal discrepancies to be noted
- Minor hairline cracking present throughout
- Moderate mildew staining noted

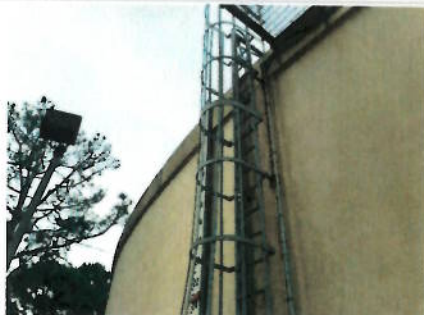
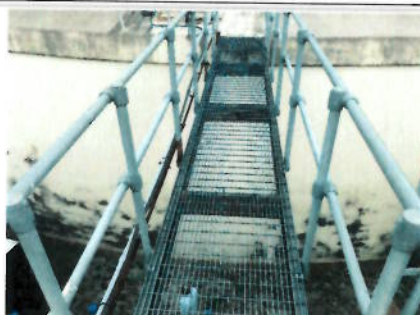
### Access Ladder Condition

- \* Must use ladder on east tank then cross over \*
- No protective coating present
- Minimal discrepancies to be noted
- Minor corrosion & staining isolated on hardware
- Roof access equipped with safety handrails

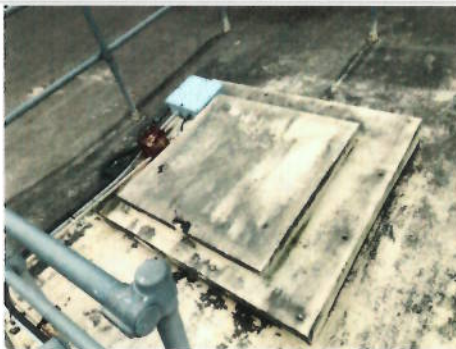
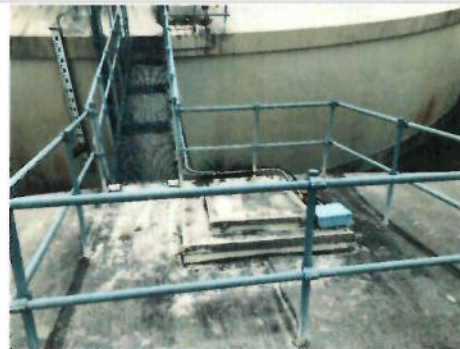
### Overall Condition: Good

**Additional Notes:**  
- Equipped w/ safety rail around access hatch  
- Heavy mildew staining noted throughout  
- Heavy chalking present  
- Moderate cracking & spalling present on riser

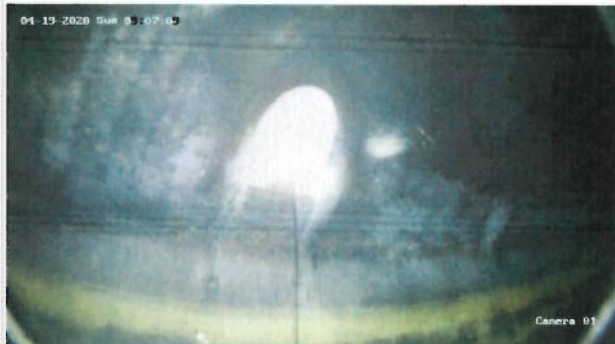
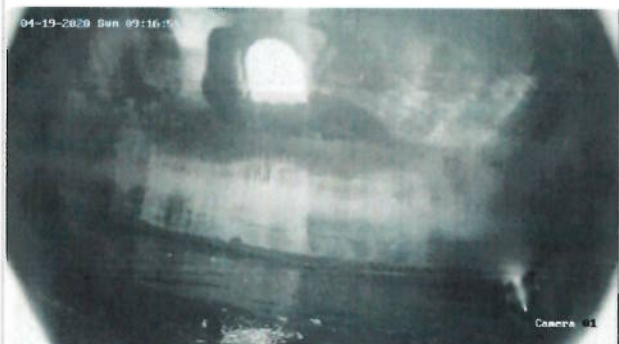
- Tank equipped w/ six(6) "frog-eye" style overflows
- All overflows(6) share equivalent ratings
- All screens present & intact
- Minimal discrepancies noted throughout penetration
